NASA Technical Paper 1524

Lubricating and Wear Mechanisms for a Hemisphere Sliding on Polyimide- Bonded Graphite Fluoride Film

Robert L. Fusaro

AUGUST 1979

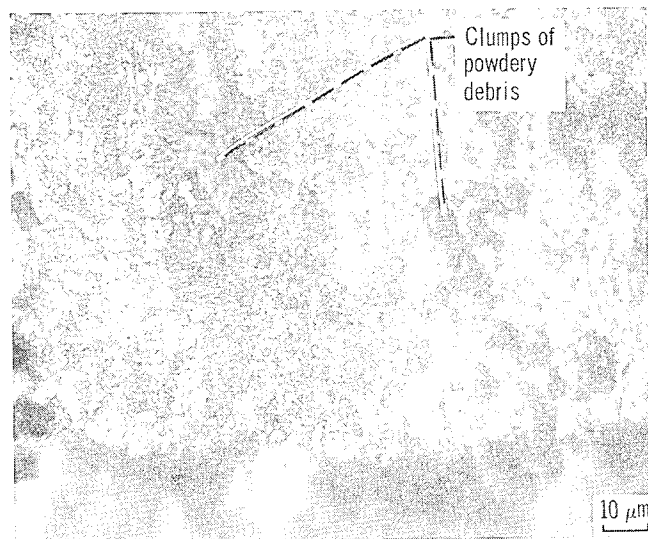
(a) Rider contact area after 4400 kilocycles of sliding.

(b) Film wear track after 4400 kilocycles of sliding.

Figure 14. - Photomicrographs of rider contact area and film wear track area after failure (high friction) had occurred. Film thickness, 45 micrometers; rider and disk substrate material, 440C HT stainless steel; rider radius, 0.476 centimeter (hemispherically tipped); load, 1 kilogram; sliding speed, 2.6 meters per second (1000 rpm); temperature, 25° C; atmosphere, moist air (10 000 ppm H₂O).

Figure 14 shows photomicrographs of the rider contact area and the film wear track area on the 45-micrometer-thick film after failure occurred. The photomicrographs also typify what happened on the 10- and 18-micrometer-thick films. The depletion of the polyimide-bonded graphite fluoride in various regions on the wear track resulted in the excessive production of extremely fine metallic wear particles. The resulting powdery mixture extended in a band (or bands) that ran around the entire circumference of the disk wear track. A matching band was found on the rider.
